UNITED STATES ENVIRONMENTAL PROTECTION AGENCY

Re: Notice of Violation
Heritage Environmental Services
EPA I.D.: IND 093 219 012

INTRODUCTION	3
FACILITY BACKGROUND	3
INVESTIGATION METHODS	4
ON-SITE INSPECTION SUMMARY	6
PROCESS OVERVIEW	6
Waste Approvals	7
Waste Acceptance, Receiving, and Tracking	8
Stabilization of Hazardous Waste	10
Dose Response Testing and Post-treatment Verification Sampling and Analysis	11
Wastewater Treatment Plant	12
Additional Treatment Processes	12
Heritage Roachdale Landfill	13
LABORATORY ACTIVITIES SUMMARY	15
SAMPLE RECEIPT AND ANALYSIS	15
ANALYTICAL PROCEDURES AND ANALYSTS	15
ANALYTICAL RESULTS	16
DATA QUALITY SUMMARY	18
SUMMARY OF OBSERVATIONS	20
KEY OBSERVATIONS	20
AREAS OF CONCERN	20
TABLES	
1 Laboratory Sample Delivery, Receipt, and Transfer	15
2 Analytical Procedures and Analysts	15
3 Laboratory Analytical Results Results for 14 Metal Constituents Covered by Universal Treatment Standards	17
4 Laboratory Analytical Results for Six Analytes Not Covered by Universal Treatment Standards	18
FIGURE	
1 Dose Response Testing Flow Diagram	9

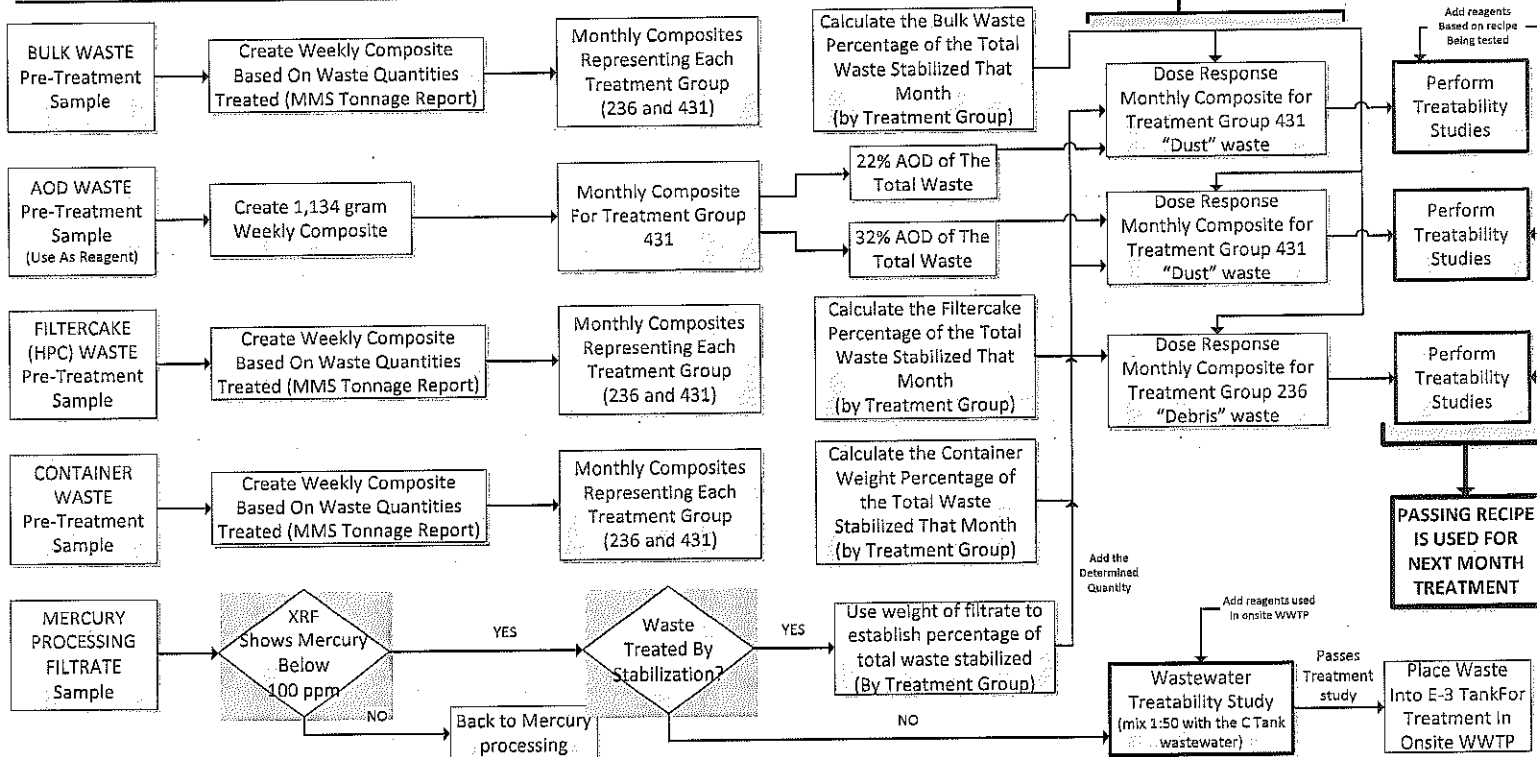
Figure 1. Dose Response Testing Flow Diagram
 Heritage Environmental Services, LLC
 Indianapolis, Indiana

For bulk hazardous wastes that will be stabilized, Heritage uses a portion of the pre-approval sample for a treatability study (**Figure 1**). Most hazardous wastes are treated in the same tank along with other hazardous wastes accepted for treatment. For any hazardous waste that can be treated with other wastes, the pre-approval sample is mixed with the “dose response” sample, which represents all wastestreams treated in mixed batches during the previous month. (The dose response testing flow is indicated in **Figure 1** and is discussed further in the next section.) For hazardous wastes that are treated as a “stand alone” waste, treatability study is conducted on that pre-approval sample only. The treatability study is used to determine the stabilization reagent formulations, or “recipes,” that will be used for treatment and, for mixed batches, to ensure that the waste is compatible with the other wastestreams.

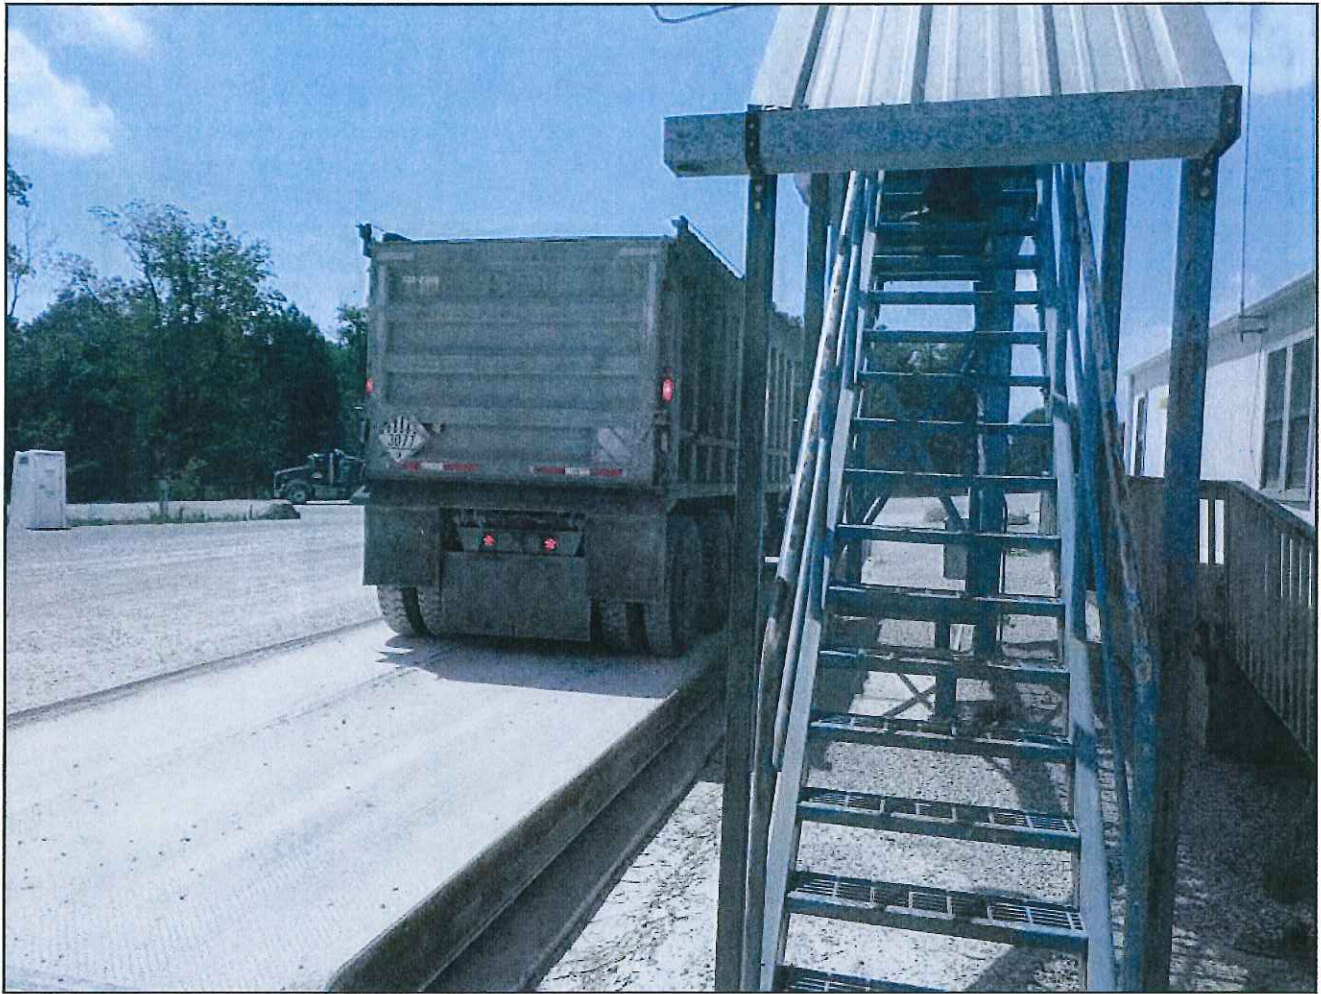
Attributes	
File Name	RIMG0003.JPG
Date Time Stamp	7/19/2012 2:56:03 PM
Photographer:	A. Ruhs
Latitude	
Longitude	
Photo Direction	
Description:	Heritage haul truck with treated waste arriving at the landfill receiving scale.

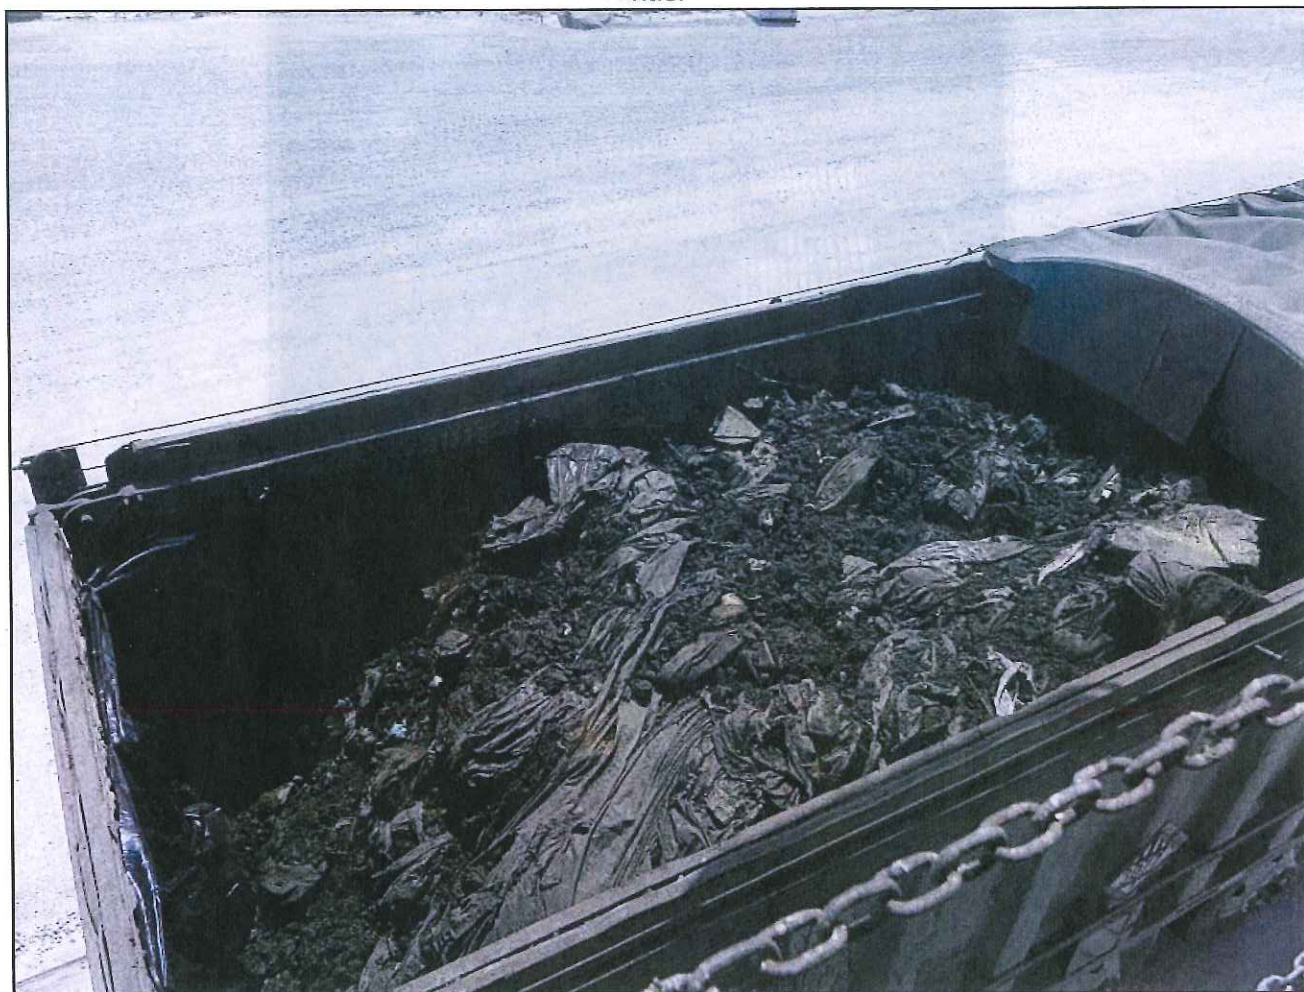
Attributes	
File Name	RIMG0004.JPG
Date Time Stamp	7/19/2012 2:57:14 PM
Photographer:	A. Ruhs
Latitude	
Longitude	
Photo Direction	
Description:	On top of sampling rack at landfill, looking into the haul truck with treated waste (waste group 9000-236).

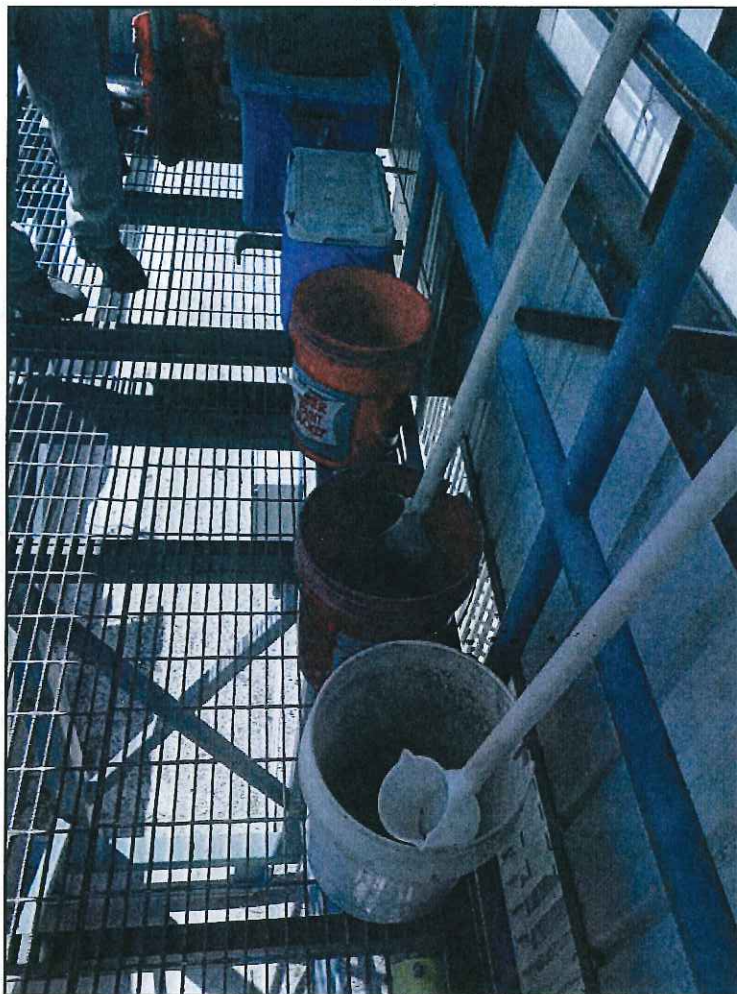
Attributes	
File Name	RIMG0005.JPG
Date Time Stamp	7/19/2012 3:02:33 PM
Photographer:	A. Ruhs
Latitude	N 39° 50' 38"
Longitude	W 86° 55' 45"
Photo Direction	257° WSW
Description:	Sampling equipment at the sampling rack at landfill receiving.

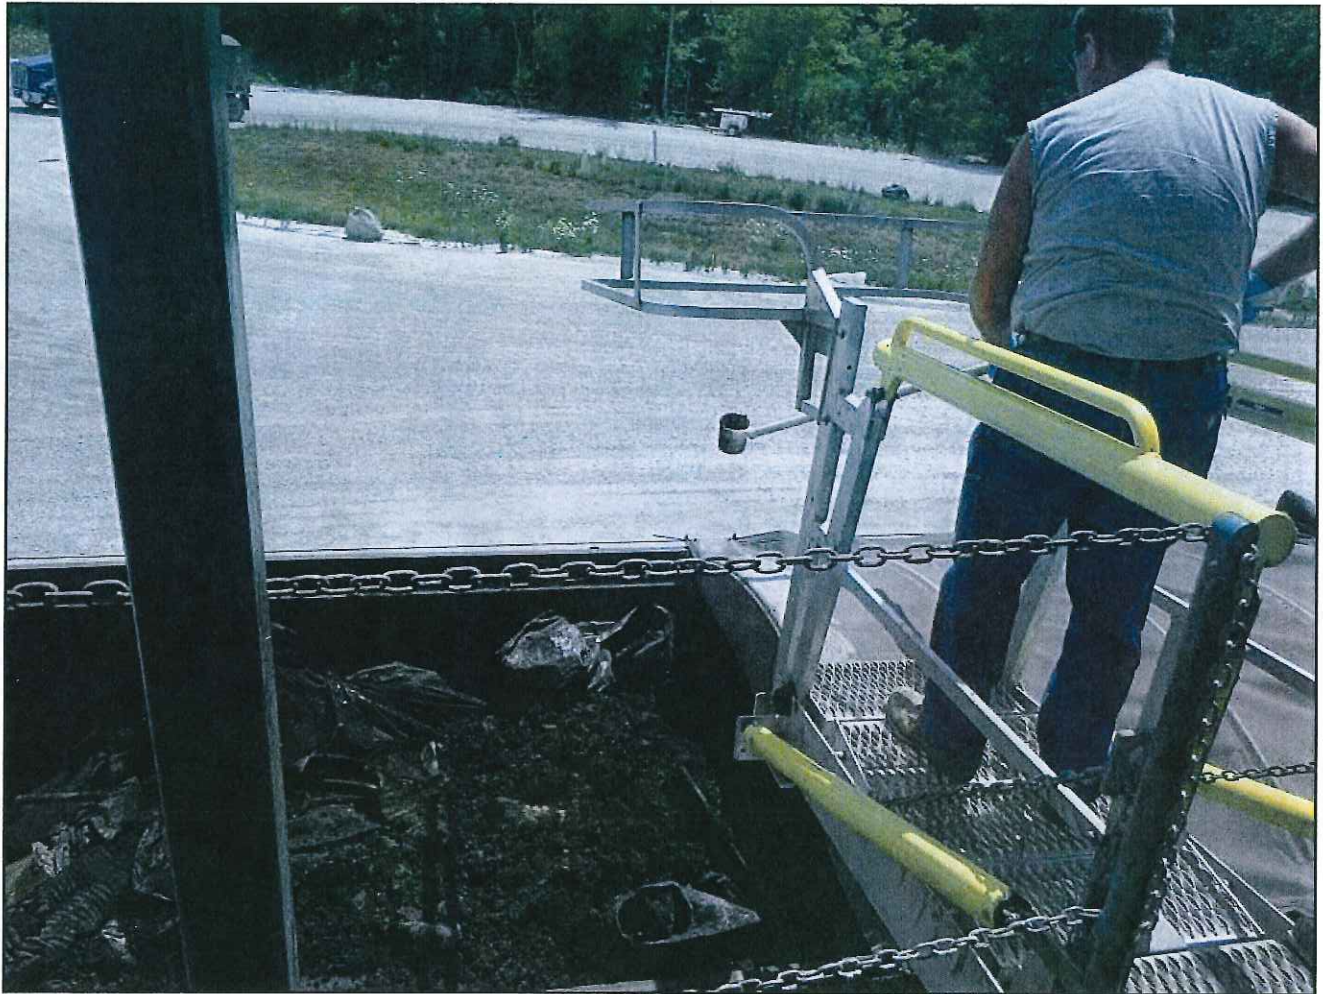
Attributes	
File Name	RIMG0007.JPG
Date Time Stamp	7/19/2012 3:04:12 PM
Photographer:	A. Ruhs
Latitude	N 39° 50' 38"
Longitude	W 86° 55' 45"
Photo Direction	185° S
Description:	Sampling of waste (9000-236) at landfill receiving sampling rack.

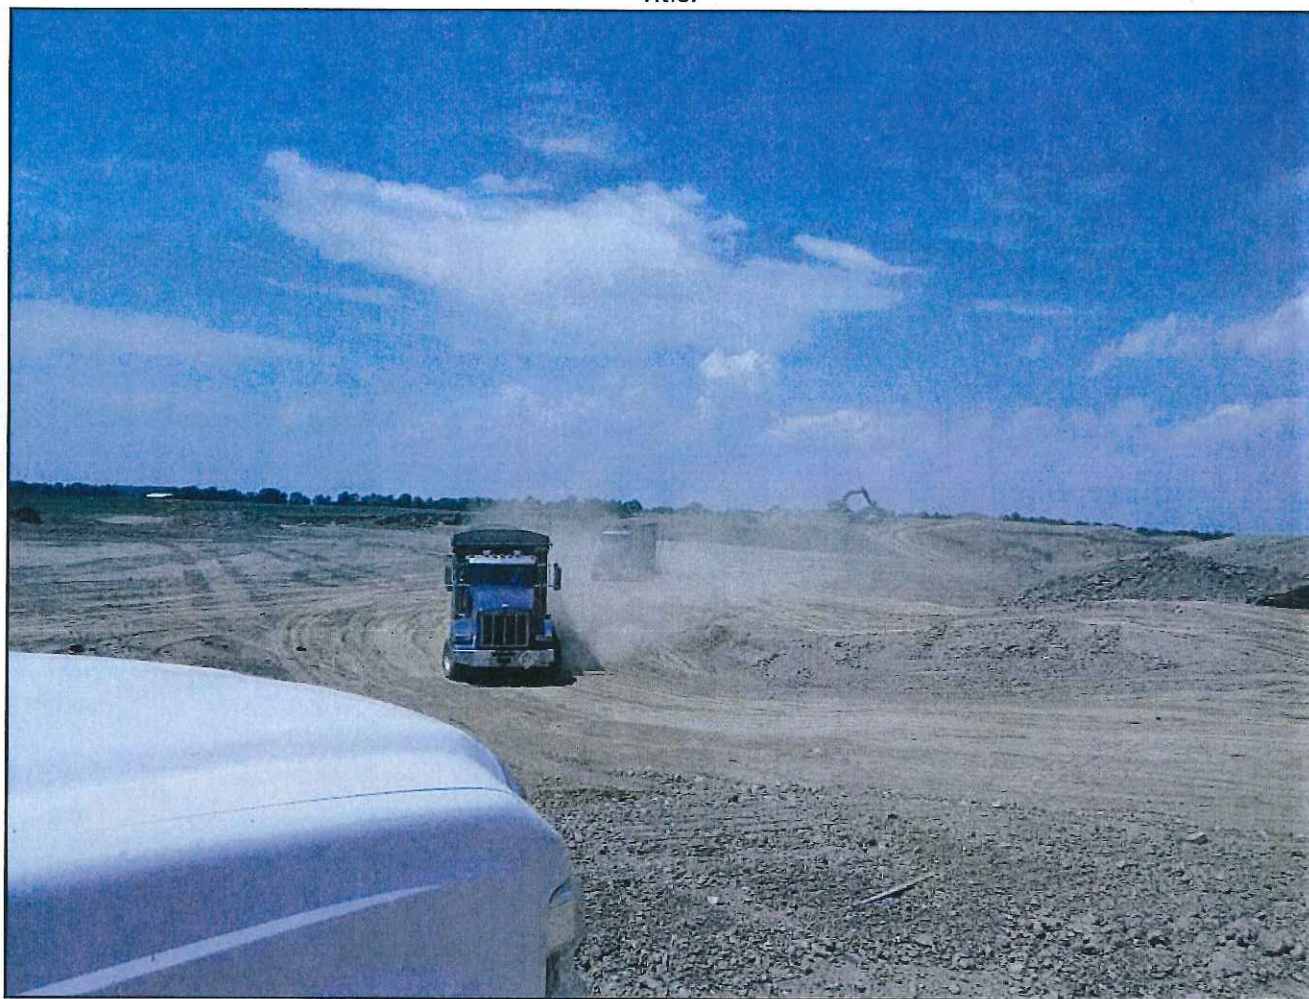
Attributes	
File Name	RIMG0009.JPG
Date Time Stamp	7/19/2012 3:13:27 PM
Photographer:	A. Ruhs
Latitude	N 39° 50' 59"
Longitude	W 86° 55' 59"
Photo Direction	28° NNE
Description:	Trucks coming up landfill Unit 2, cell 1, going to dump in cell 2.

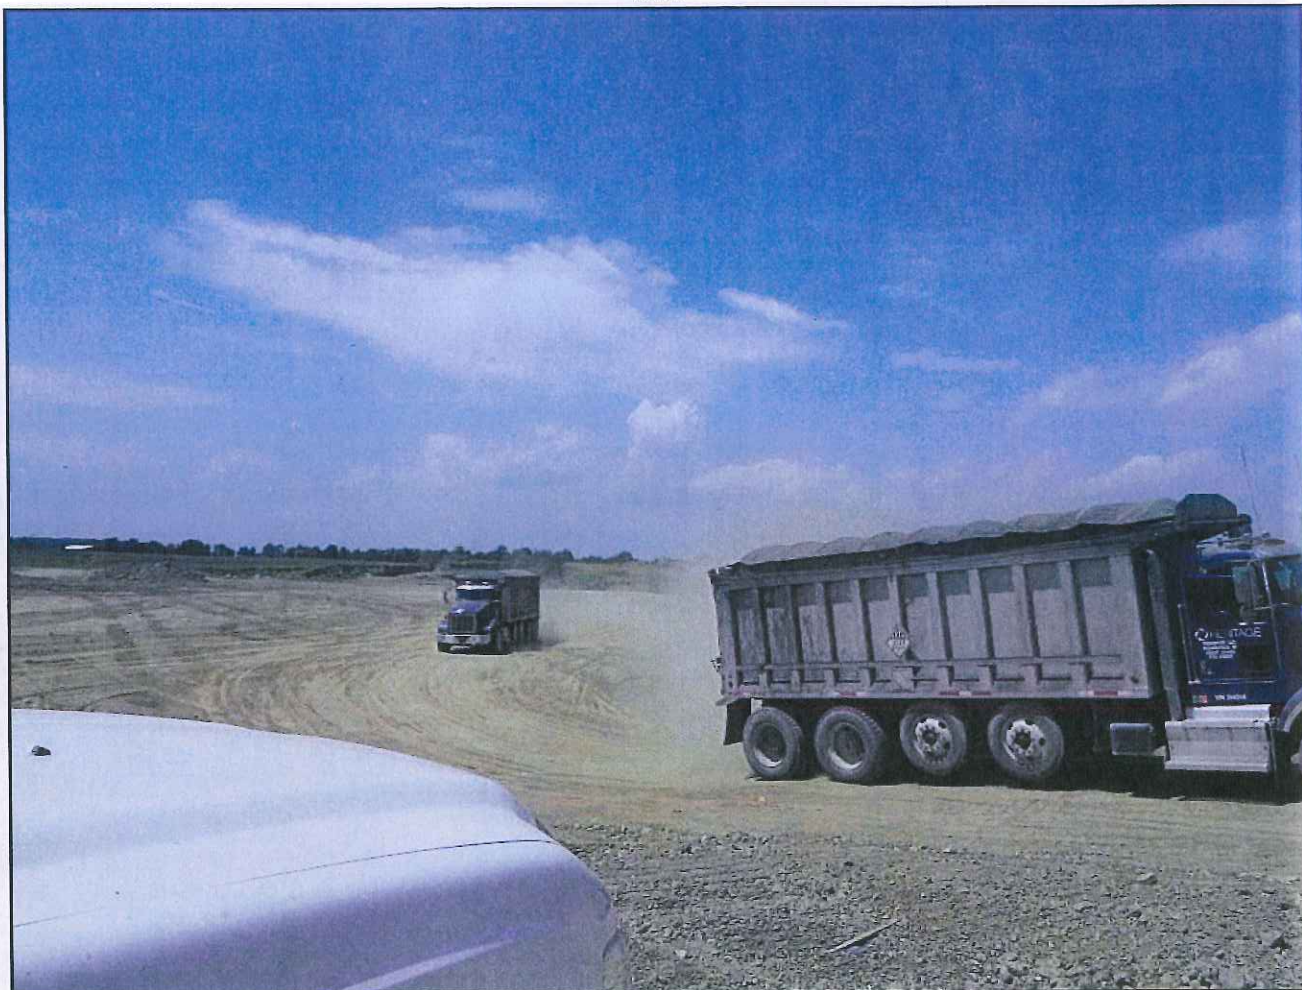
Attributes	
File Name	RIMG0010.JPG
Date Time Stamp	7/19/2012 3:13:32 PM
Photographer:	A. Ruhs
Latitude	N 39° 50' 59"
Longitude	W 86° 55' 59"
Photo Direction	41° NE
Description:	Trucks coming up landfill Unit 2, cell 1, going to dump in cell 2.

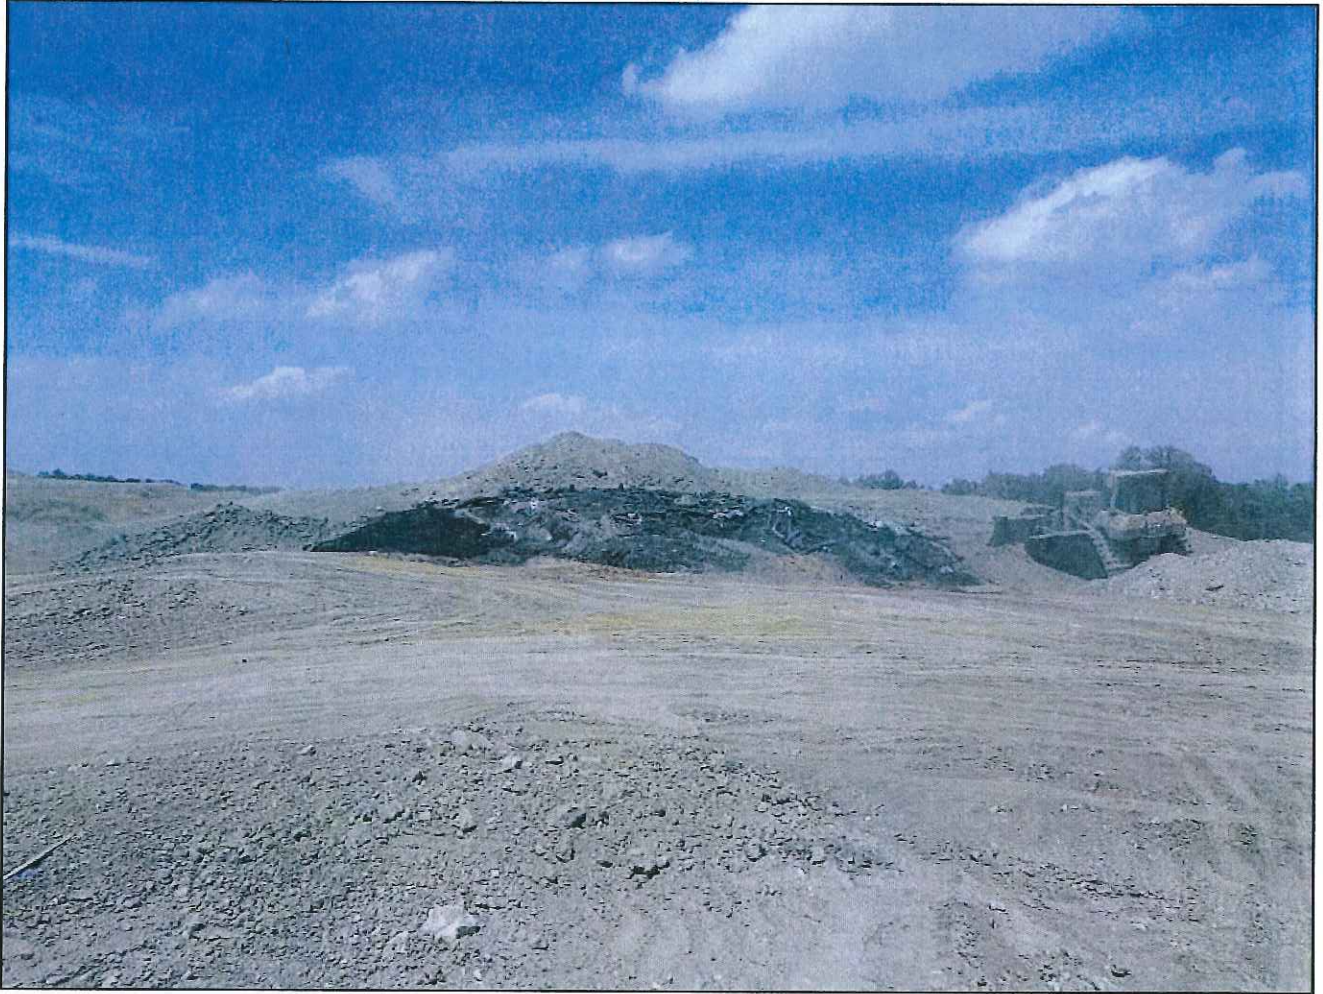
Attributes	
File Name	RIMG0011.JPG
Date Time Stamp	7/19/2012 3:13:39 PM
Photographer:	A. Ruhs
Latitude	N 39° 50' 59"
Longitude	W 86° 55' 59"
Photo Direction	86° E
Description:	Overview of active face at Unit 2 landfill, cell 2.

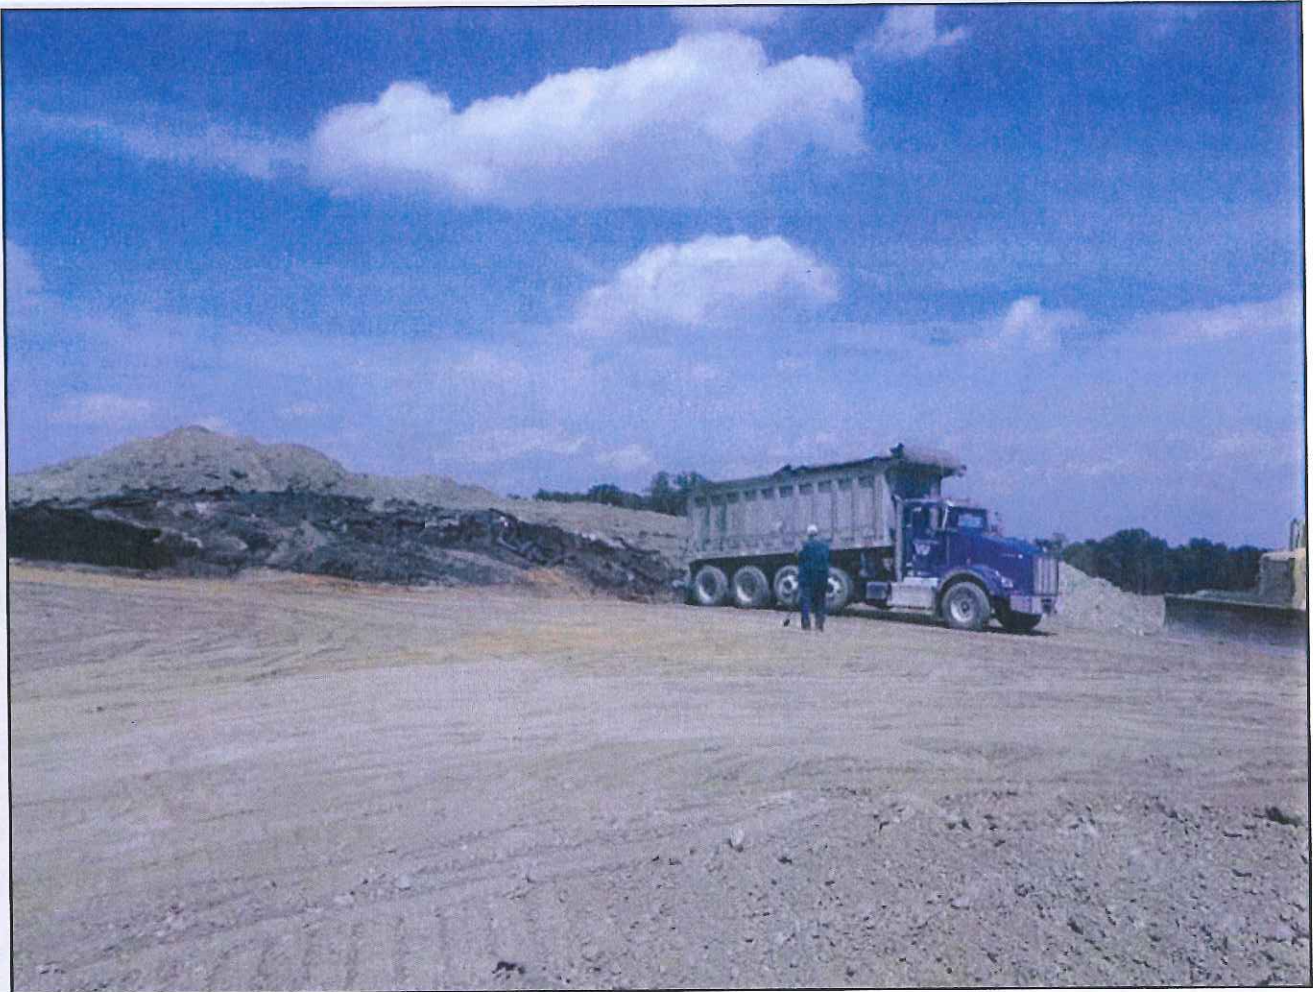
Attributes	
File Name	RIMG0012.JPG
Date Time Stamp	7/19/2012 3:15:12 PM
Photographer:	A. Ruhs
Latitude	N 39° 50' 59"
Longitude	W 86° 55' 59"
Photo Direction	46° NE
Description:	Dumping of waste at unit 2 landfill, cell 2 active face

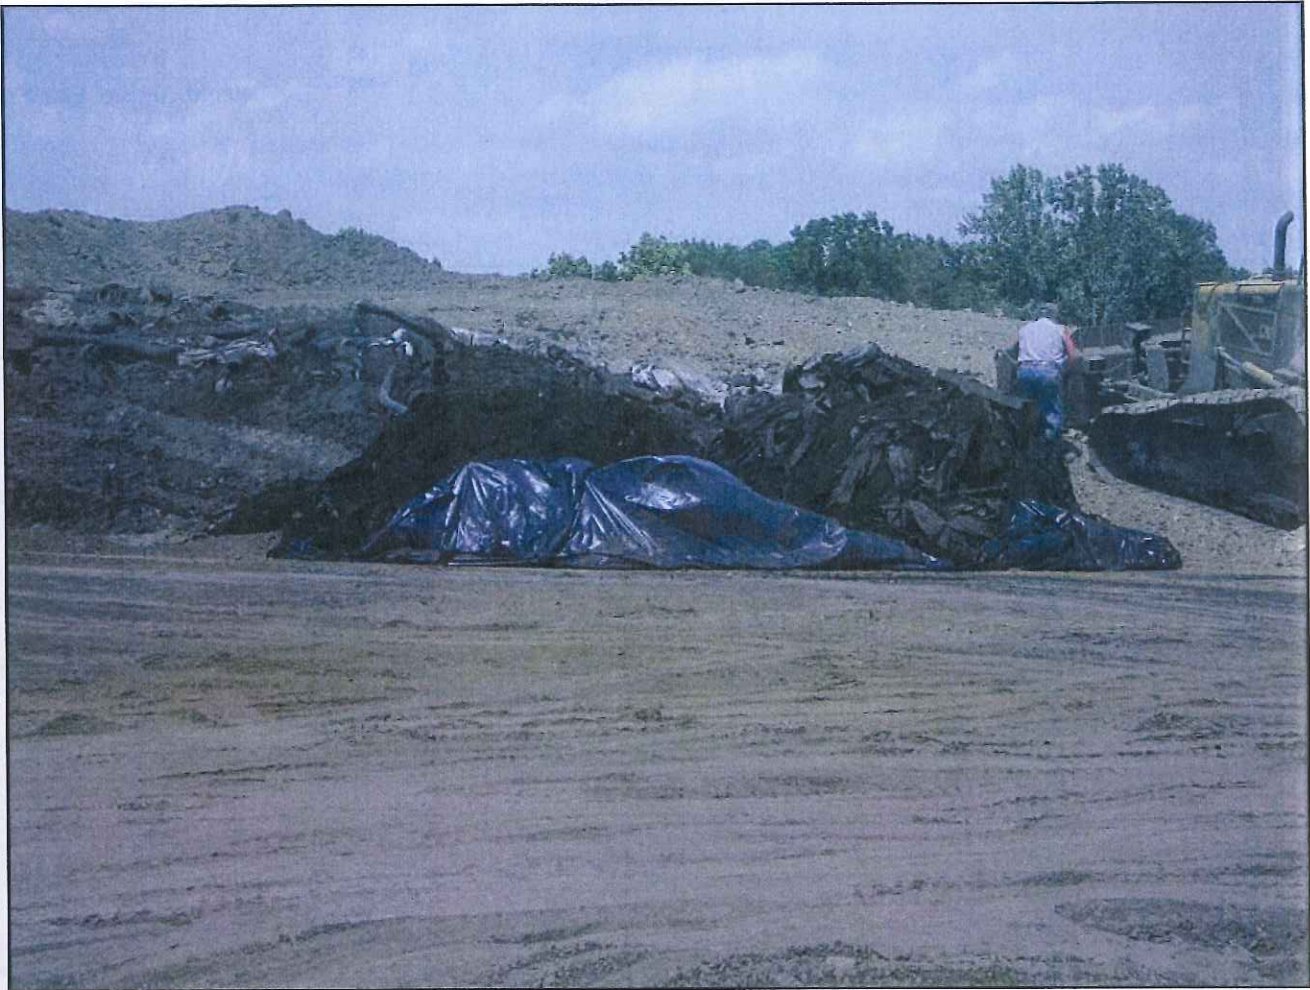
Attributes	
File Name	RIMG0022.JPG
Date Time Stamp	7/19/2012 3:19:23 PM
Photographer:	A. Ruhs
Latitude	N 39° 50' 59"
Longitude	W 86° 55' 59"
Photo Direction	23° NNE
Description:	Close-up on both dumped wastes.

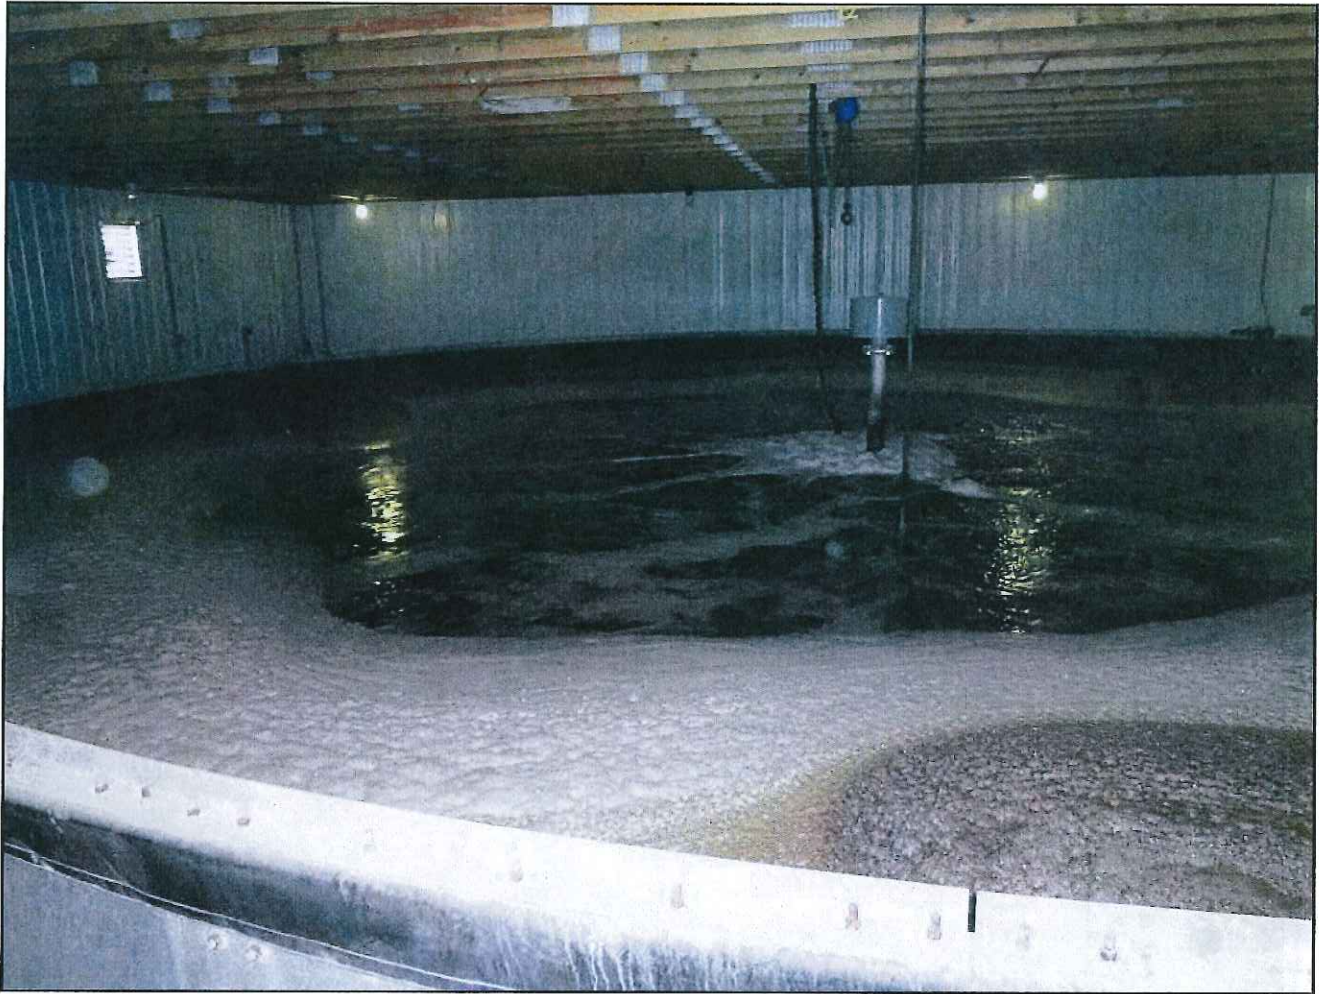
Attributes	
File Name	RIMG0027.JPG
Date Time Stamp	7/19/2012 3:30:44 PM
Photographer:	A. Ruhs
Latitude	N 39° 50' 52"
Longitude	W 86° 55' 56"
Photo Direction	177° S
Description:	Inside "bio-treatment" area at the landfill, close-up on aeration tank used to pre-treat the leachate to meet BOD and phenol/p-cresol limits at the CWT.

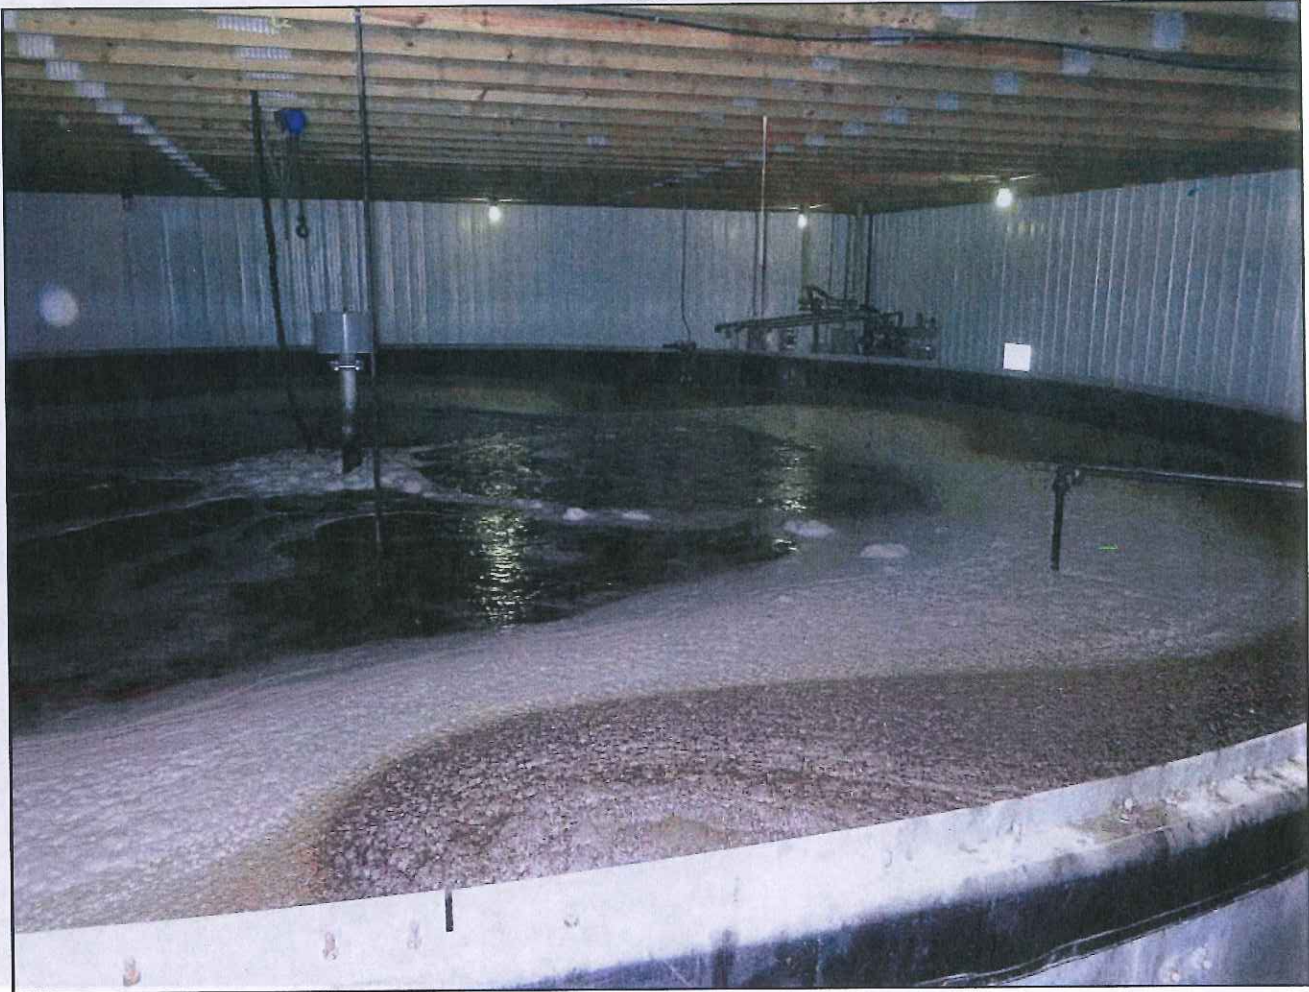
Attributes	
File Name	RIMG0028.JPG
Date Time Stamp	7/19/2012 3:30:51 PM
Photographer:	A. Ruhs
Latitude	N 39° 50' 52"
Longitude	W 86° 55' 56"
Photo Direction	201° SSW
Description:	Inside "bio-treatment" area at the landfill, close-up on aeration tank used to pre-treat the leachate to meet BOD and phenol/p-cresol limits at the CWT.

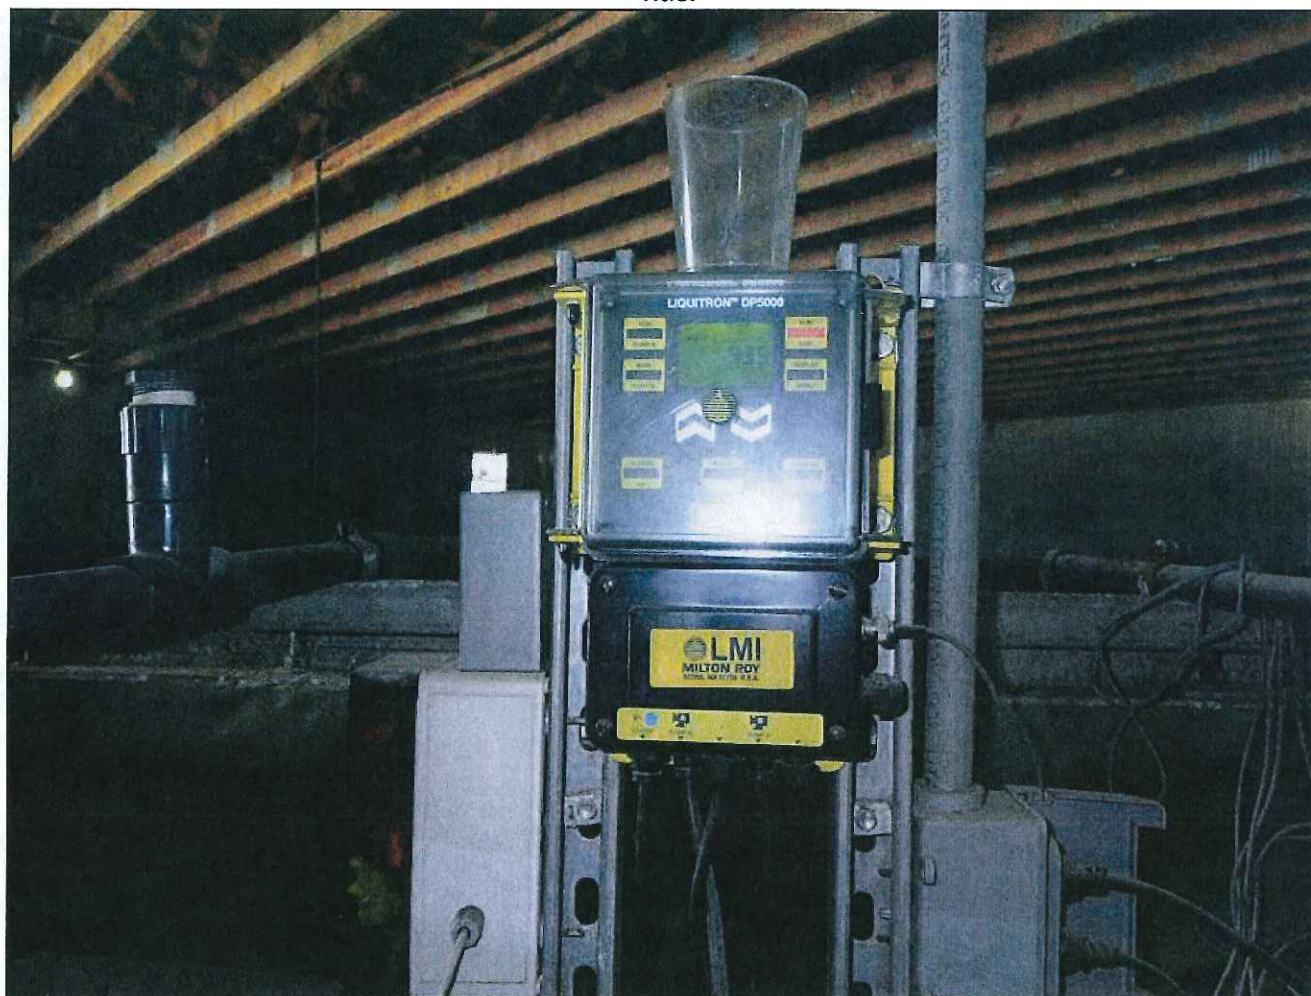
Attributes	
File Name	RIMG0029.JPG
Date Time Stamp	7/19/2012 3:36:56 PM
Photographer:	A. Ruhs
Latitude	N 39° 50' 50"
Longitude	W 86° 55' 56"
Photo Direction	145° SE
Description:	Close-up on pH meter at the "bio-treatment" for leachate pre-treatment at the landfill. HCl is used to adjust pH.

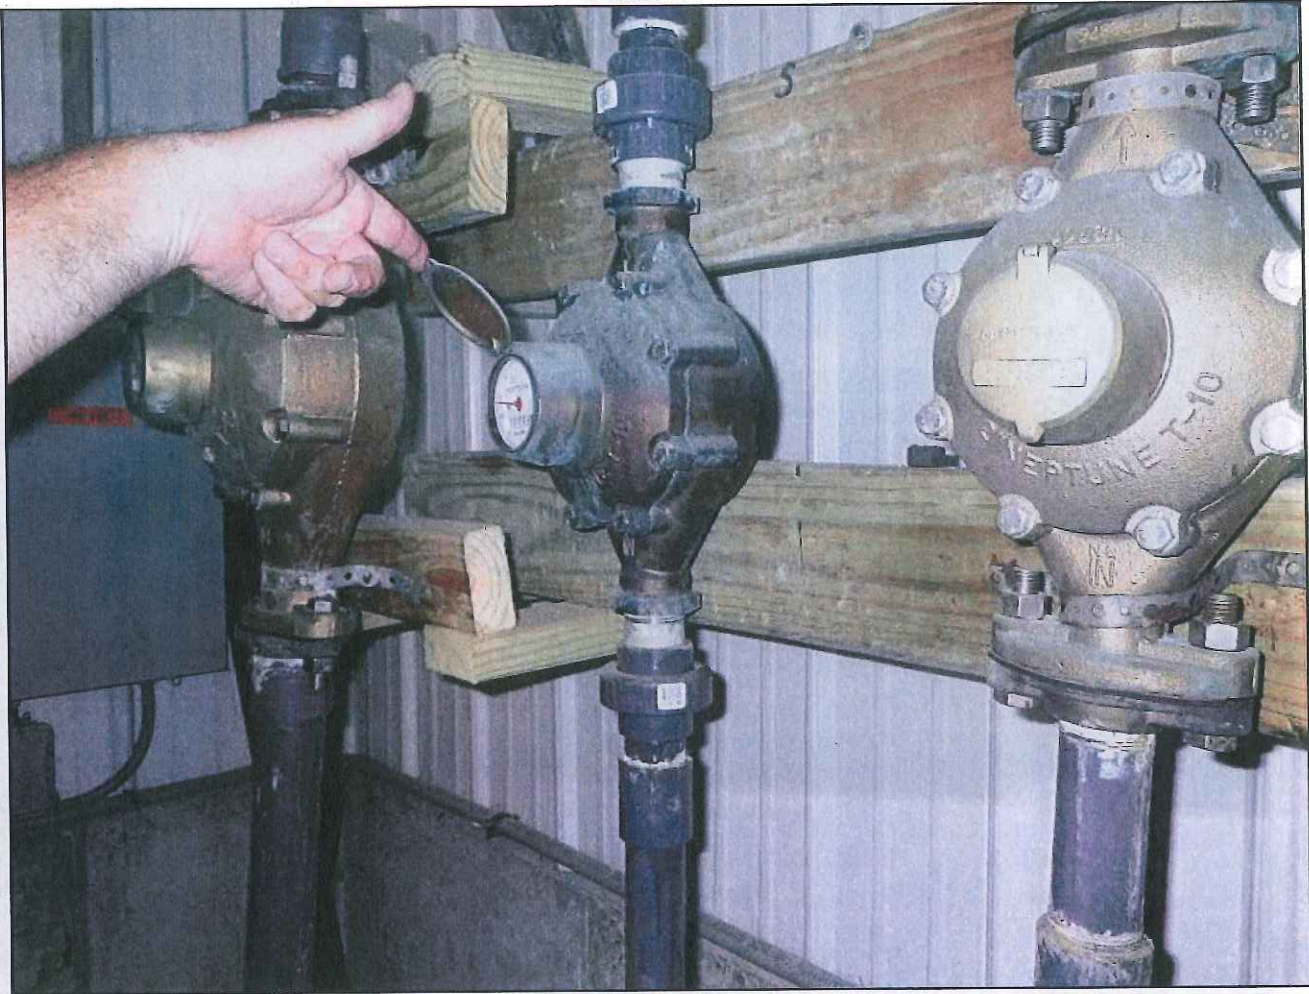
Attributes	
File Name	RIMG0030.JPG
Date Time Stamp	7/19/2012 3:39:45 PM
Photographer:	A. Ruhs
Latitude	N 39° 50' 50"
Longitude	W 86° 55' 56"
Photo Direction	203° SSW
Description:	Flowmeters for leachate coming from the primary leachate system for Unit 2 cell 1 (left), and cell 2 primary and secondary system (right).

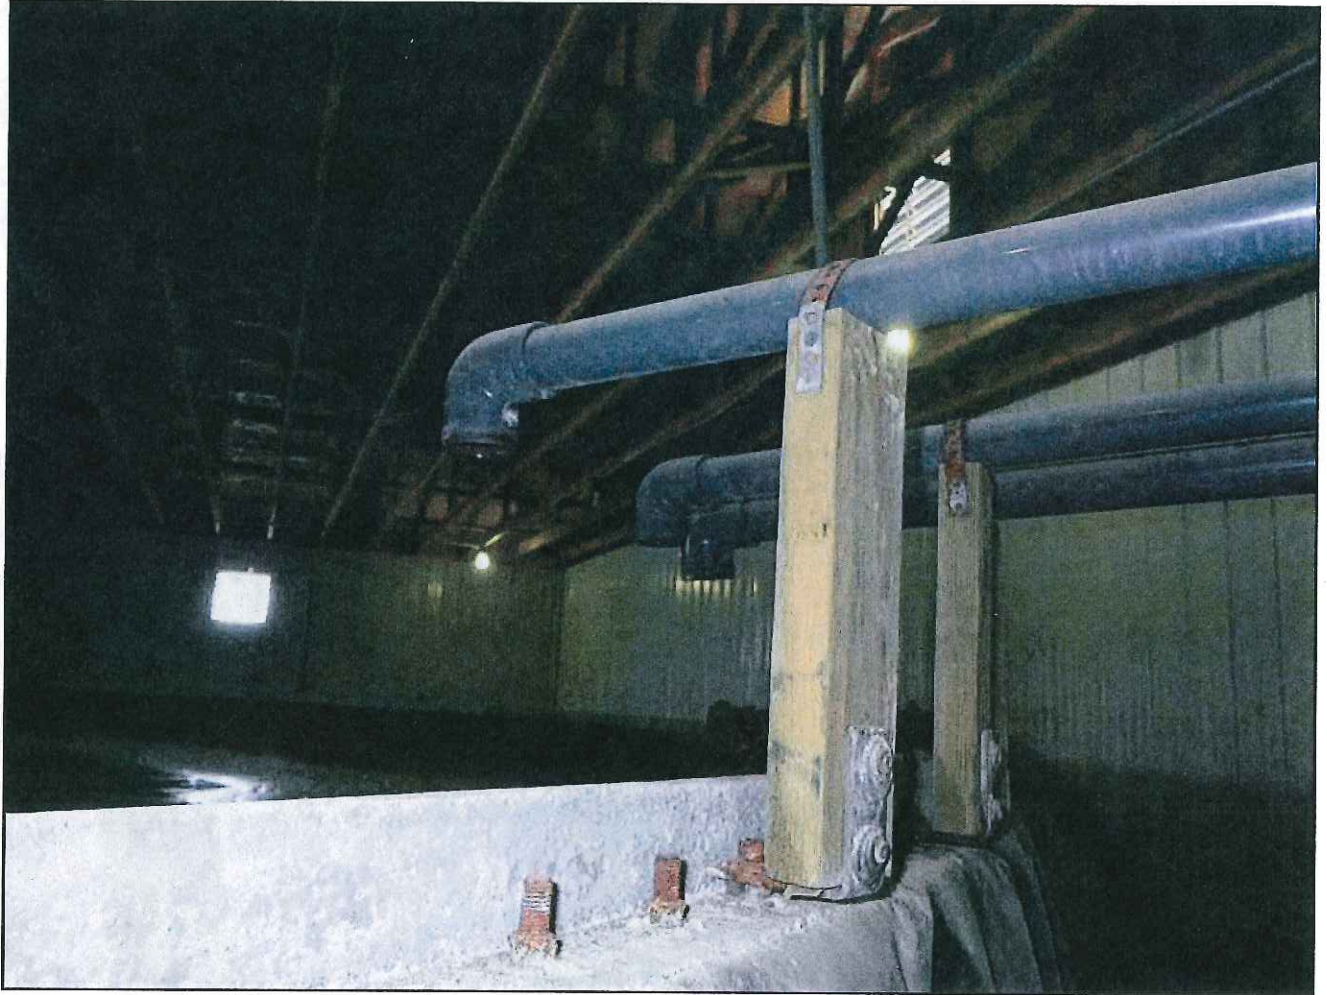
Attributes	
File Name	RIMG0031.JPG
Date Time Stamp	7/19/2012 3:39:58 PM
Photographer:	A. Ruhs
Latitude	N 39° 50' 50"
Longitude	W 86° 55' 56"
Photo Direction	83° E
Description:	Discharge lines into the aeration tank for unit 2 cell 2 primary (left) and secondary leachate (middle), and cell 1 primary leachate (right).

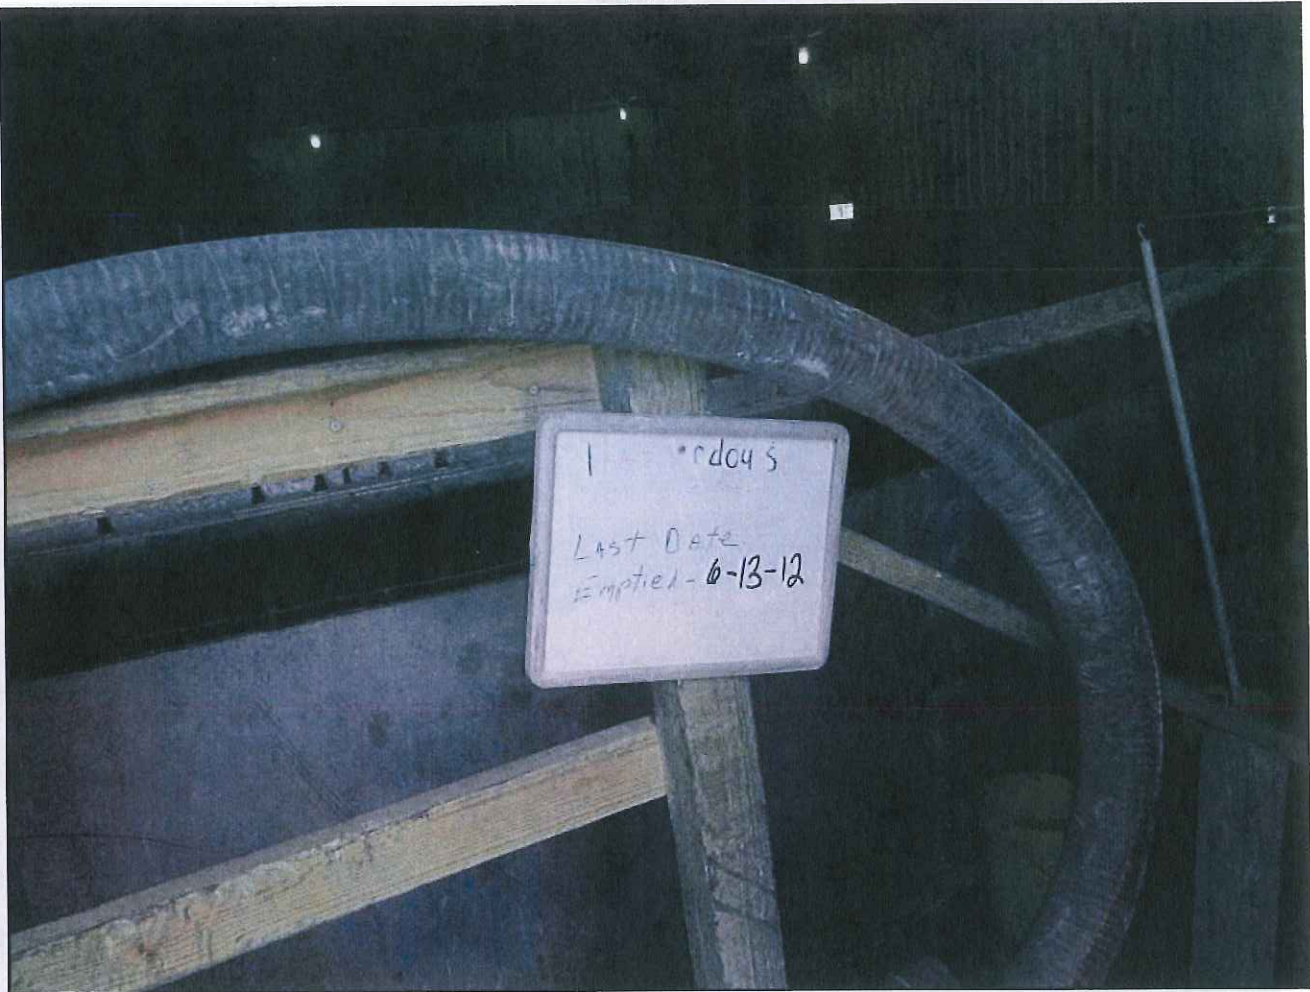
Attributes	
File Name	RIMG0032.JPG
Date Time Stamp	7/19/2012 3:42:37 PM
Photographer:	A. Ruhs
Latitude	N 39° 50' 53"
Longitude	W 86° 55' 56"
Photo Direction	203° SSW
Description:	Sign at the entrance of the bio-treatment area (aeration tank), which is a less-than-90-day collection tank for Unit 2 cell 1 and leachate.

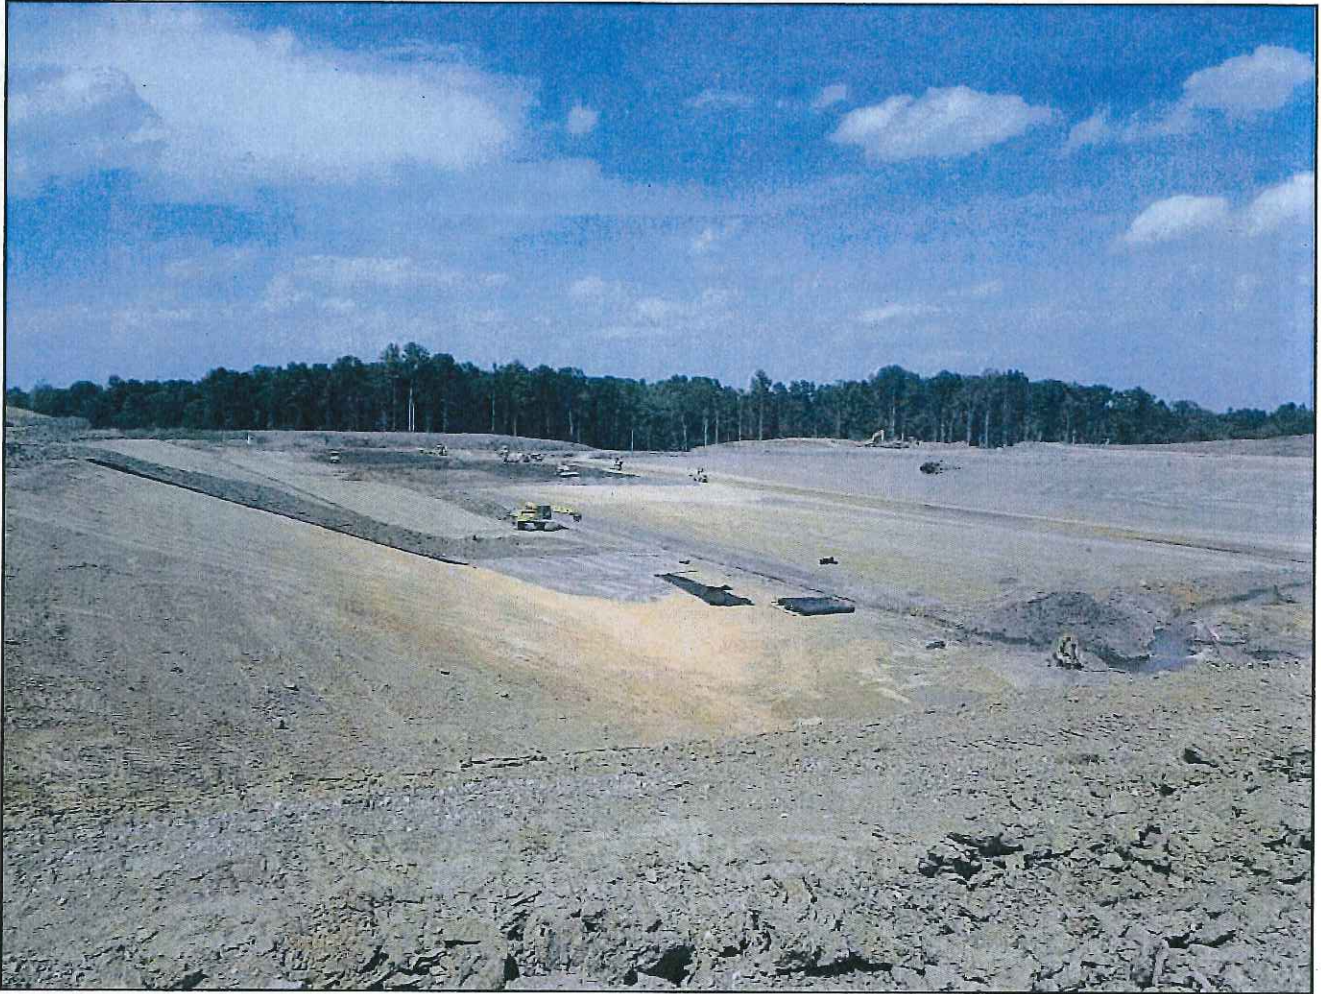
Attributes	
File Name	RIMG0033.JPG
Date Time Stamp	7/19/2012 3:43:50 PM
Photographer:	A. Ruhs
Latitude	N 39° 50' 53"
Longitude	W 86° 55' 55"
Photo Direction	51° NE
Description:	Overview shot of the construction of Unit 2 cell 3.
